APPLICATION GOAL: To remove static charge from the plastic film that individual condiment packets are made of, in order to increase the life of the print heads used to label the packets.

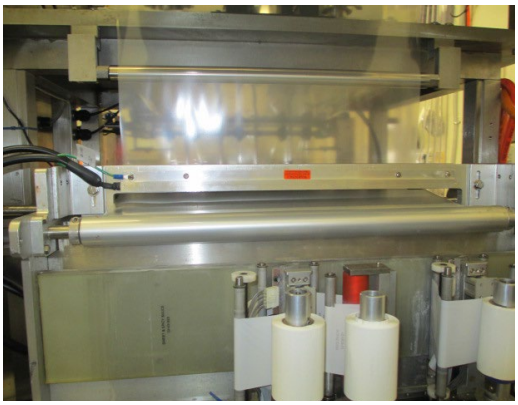
They receive the film on 18" (457mm) wide rolls. A high static charge develops on the film as it unwinds. This meter is measuring a static charge of 16.9kV on their film stock unwind station.

When the film's path is turned horizontal, this was an ideal location to install a **Model 8018 18" (457mm) Ionizing Bar**, *(right)* connected to a **Model 7960 2-Outlet, 115VAC Power Supply** *(not shown)*. Since the static charge only presents a problem on the side to be printed, only the "top" side of the film needs to be passed.

Once the film has passed beneath the Ionizing Bar, the static charge has been dramatically reduced…they are using EXAIR's **Model 7905 Digital Static Meter** to quickly, conveniently, and reliably monitor for proper operation. As you can see, the Ionizing Bar is reducing the static charge from almost 17kV to a fraction of a kV.
